Figure 1: Water Bath Configuration for Performing the J&L Modified Kawasaki Condensate Corrosion test.

Table 2: J&L Modified Kawasaki Condensate Corrosion Test Results: Maximum Pit Depth in Substrate (µm).

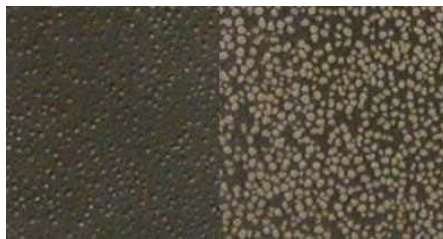
Figure 4: Neukote™ sample - pimples after test completion on the left and pimples removed on the right (approx. 7x).

The last two samples were the Neukote™ samples. These samples had less pitting than the bare and Al409 samples in all three sets. Neukote™ 439 performed approximately the same as Neukote™ 409. Several things were noticed during the corrosion removal process for these coatings. The Neukote™ coating was extremely difficult to remove. The nitric solution and ultrasonic cleaning had a minimal effect on the removal of the coating and the corrosion. What was discovered, was that the Neukote™ formed small pimples all over the sample (see Figure 4).

This is thought to have happened due to the sulfur that was present in the test solution [4]. Pitting occurred underneath these pimples. It should be noted, corrosion was only found under a small percentage of these pimples. When looking at the samples from a distance, these pimples were not noticeable.
